# Q2/13mtr Wright & Levrantos

## Service Report, Orams Marine Village

**Service Type:** Replacement Standing Rigging

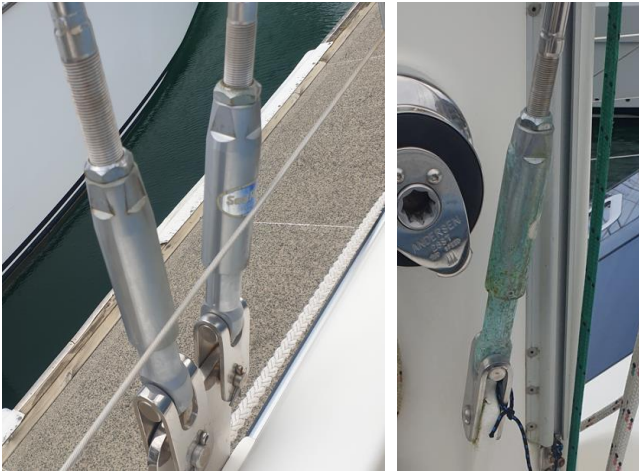
Old Rigging Screw sample images

1. **Rigging Replaced** – all the standing rigging was replaced with new Dyform 316 Stainless Steel Hama wire. All Ball tang swages were replaced, as well as all the turn buckles.

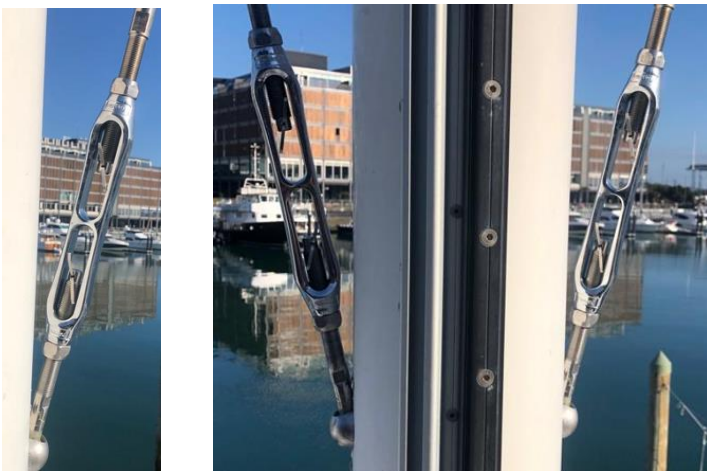
New rigging screws sample image (all replaced)

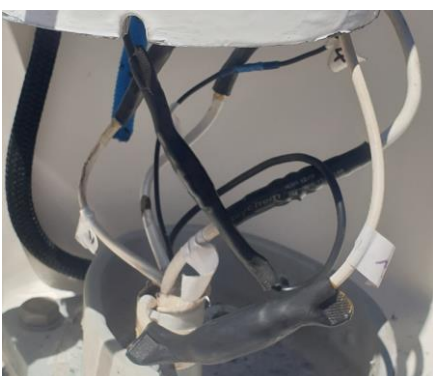
New wiring at mast base

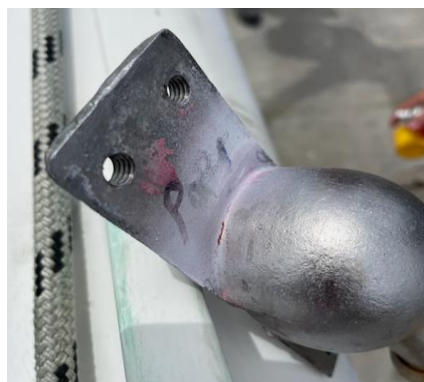
Port ball tang cracked so replaced

2. **Ball Tang** – the two ball tangs for the caps were replaced as one of the tangs was found to have a crack in it after the fitting was NDT'd.
3. **Forestay** – The forestay was replaced in December 2021 with new Dyform 316 stainless steel wire, new toggle and eye swage end fittings.
